Experimental Evaluation of Seismic Residual Performance for Deteriorated Rubber Bearings in Highway Bridges

6th International Conference on Advances in Experimental Structural Engineering
11th International Workshop on Advanced Smart Materials and Smart Structures Technology
August 1-2, 2015, University of Illinois, Urbana-Champaign, United States

Kunihiro HAYASHI¹, Yukio ADACHI², Naota SAKAMOTO³, Akira IGARASHI⁴
and Ji DANG⁵

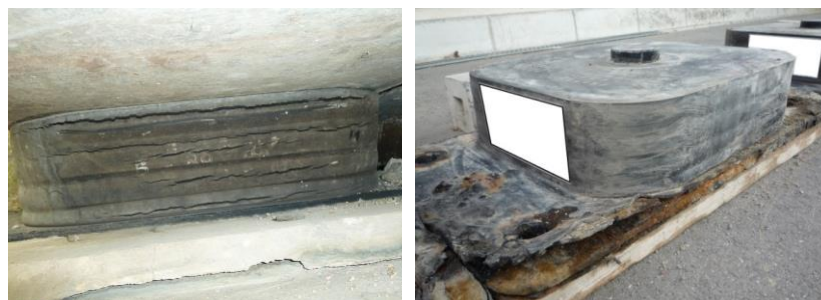
Figure 2.2 Damage status and cracks of ring bearings

The bearings had been used in service for 27 years. As can be seen in Figure 2.2, surface cracks appear on the bearings because of aging deterioration of the rubber material over time. Moreover, the bottom plate suffered partial corrosion due to water leaked through the expansion joint.

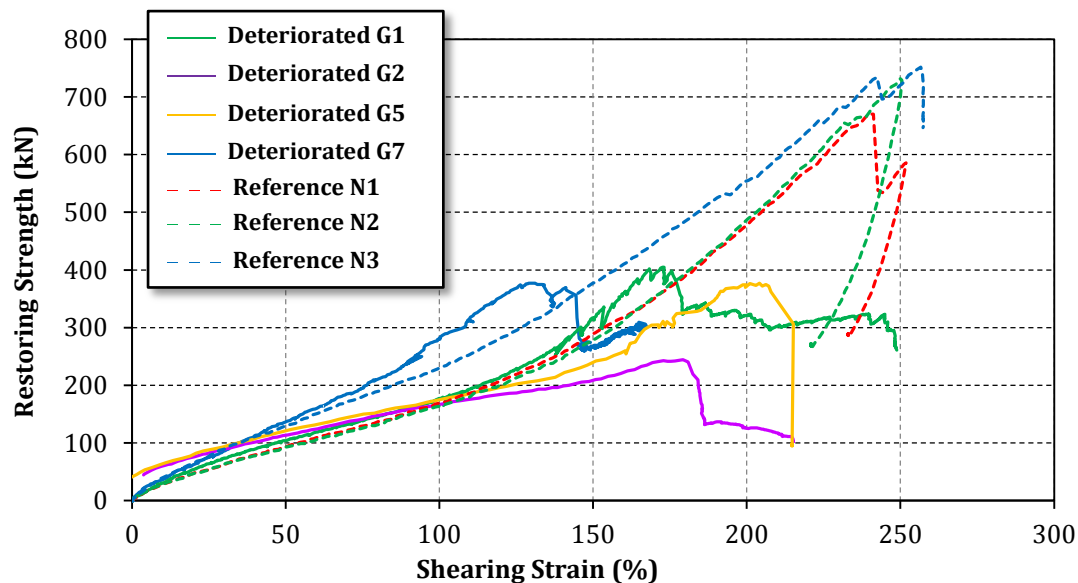
Figure 3.2 Result of UD tests

The restoring force curves obtained by the UD tests are shown in Figure 3.2. The reference sample bearings failed at 240% strain on average, satisfying the allowable shear strain requirement of 150%, although G7 failed at 131% strain. On the other hand, the failure of G1, G2 and G5 took place at shear strains exceeding 150%. Possible reasons for the variation in the failure strain among the samples include the difference in the progress of aging deterioration caused by environmental conditions in service period, manufacturing process or interaction between those factors.

Furthermore, the maximum restoring force of the four deteriorated bearings was 40% less than that of the reference bearing. Since the most influential factor to the load capacity degradation was inferred to be the aging deterioration, several supplemental tests had been conducted in order to evaluate the influence of the deterioration.

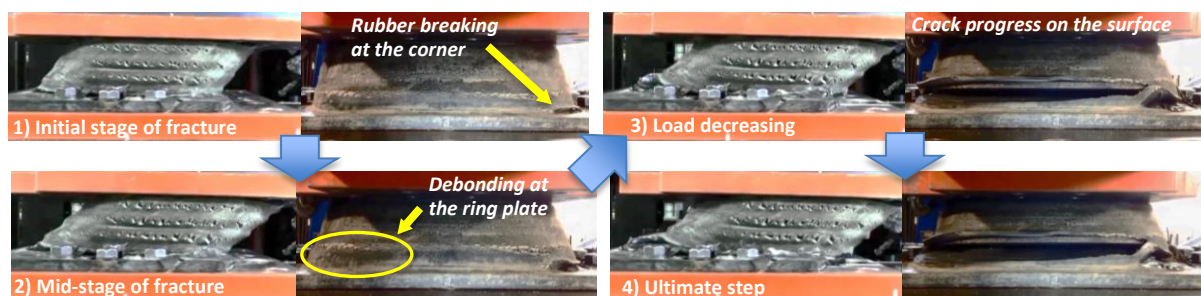
Figure 3.3 Video capture of UD test in G7

The onset of fracture and its progress were analyzed by the video image of the UD tests. The images of the G7 test are shown in Figure 3.3. Debonding began from the ring plate, followed by a gradual progress of cracking extended to the bearing surface, and then the ultimate state was reached. The fracture was induced along the boundary between the bottom plate and rubber. The process of fracture forming is identical for all the deteriorated bearing samples. On the other hand, the fracture forming in the reference bearings is different from this description. The fracture was induced within the rubber layer between lower ring plates as commonly assumed in the design of bearings.

Although many ozone cracks are generated in ring bearings during the regular service, any extension and growth of these cracks that cause fracture of rubber layers were not observed in the tests. Therefore, ozone cracks on the surface of the bearings are not considered to be a critical factor that affects the seismic performance or bearing fracture process.

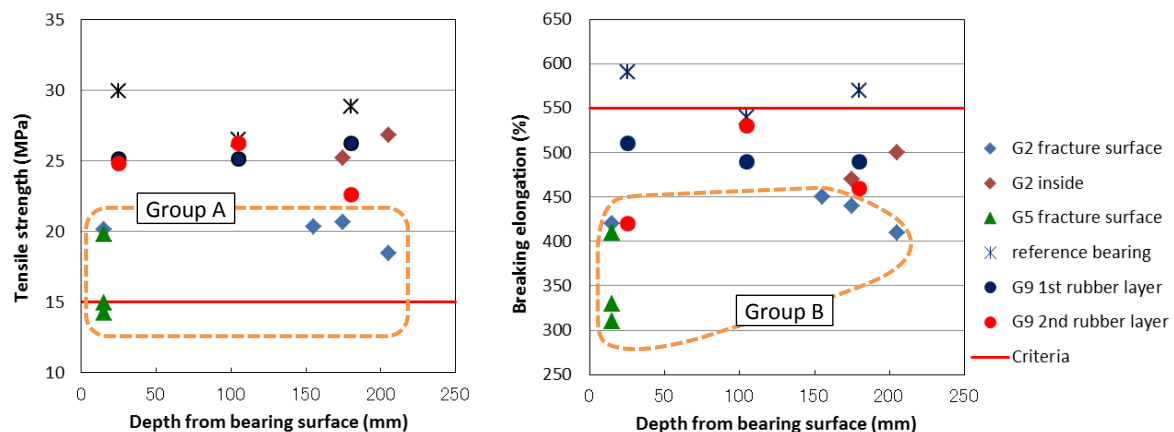
Figure 3.5 Results of tensile tests

The test result indicates that the strength and deformation capacity of the deteriorated bearings are lower than that of the reference bearings. It should be noted that the ultimate elongation capacity of the deteriorated bearings does not reach the criterion of 550%, implying that the degradation of the rubber is evident. Groups A and B in these plots correspond to the specimens taken from the fracture surfaces between the bottom plate and rubber, and the values of these groups consistently lower than the values of the other samples taken from different locations. In particular, since the samples of G5 were taken near the area where rust was seen, this result suggests that water or other external factors may contribute the deterioration process of rubber.

Since the rubber samples taken from within the rubber layers of G9 are not subjected to significant aging deterioration, the load capacity degradation observed in the UD test cannot be elucidated by the hypothesis of aging deterioration of rubber material alone. On the other hand, the surface rubber of the bearing is more susceptible to aging deterioration due to exposure to water or air. It implies that cracks are easily induced in the surface rubber and the intrusion of water through the cracks may introduce corrosive action on the boundary between the bottom steel plate surface and neighboring rubber layer.

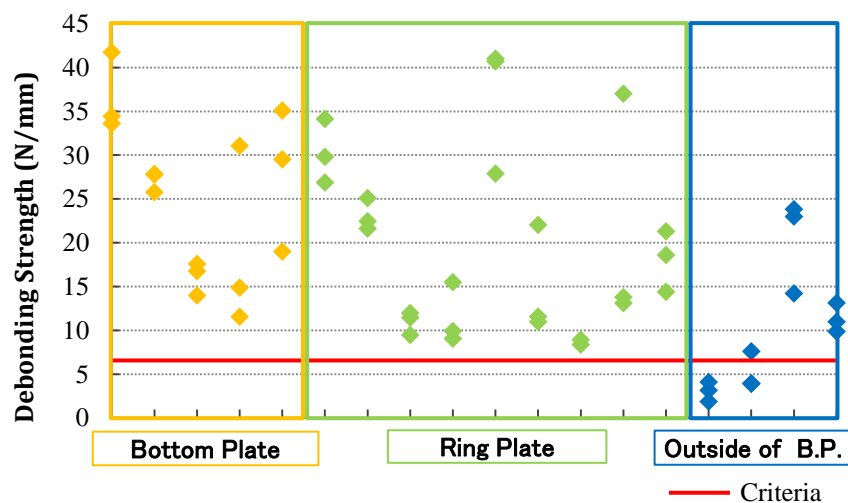
Figure 3.6 Results of adhesion debonding tests

The adhesion debonding tests were conducted using the samples taken from the deteriorated and the reference bearings. All measurement results on the debonding strength are shown in Figure 3.6 indicating the difference of the debonding properties depending on the location. While the debonding strengths at the bottom plate and ring plate satisfy the requirement of 7N/mm specified in the manufacturing criteria, that at the outer bottom plate is not always sufficient. Figure 3.7 shows the photos of adhesion debonding tests at outside of the bottom plate of the deteriorated bearing G7 and reference bearing N0. In contrast to the smooth debonding surface of G7, a striation pattern is observed for the case of N0. These results suggest that the debonding strength of the bonding area in the deteriorated bearings is lowered by a loss of adhesive action.

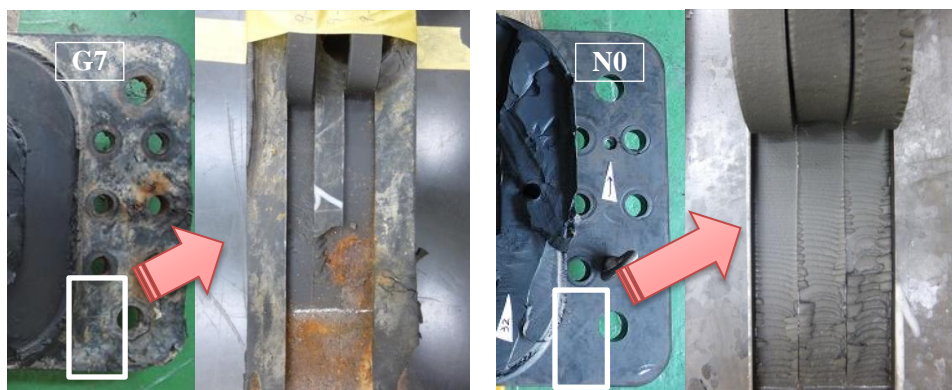
Figure 3.7 Appearance of outside of bottom plate in adhesion debonding test (Left: G7, Right: N0)

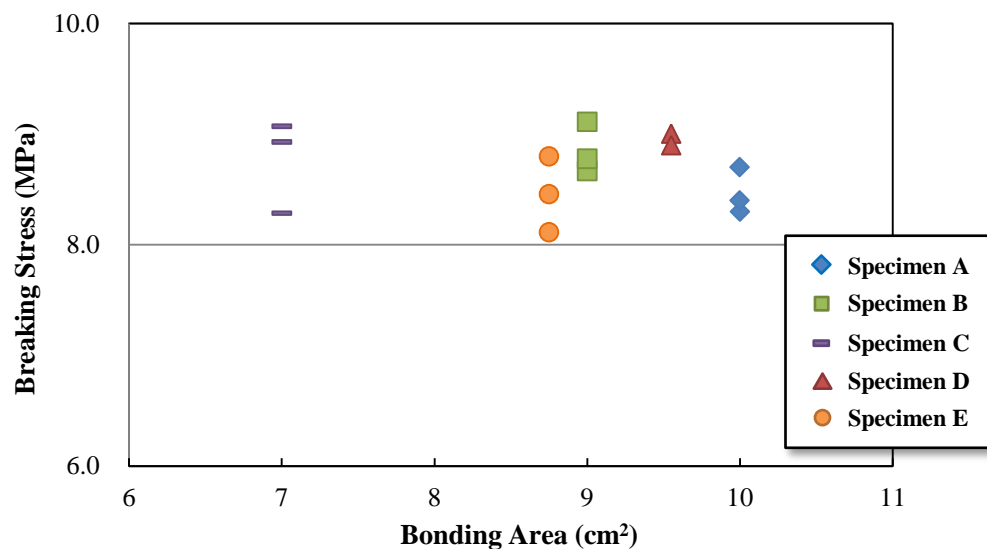
Figure 3.9 Results of lap shear tests

The difference of the failure stresses between the specimens is not significant. It is also noteworthy that the results of the specimen E are in the same range in spite of possible high stress concentration in the specimen E due to partly cutout. When a good bonding condition is ensured, the bonding between the steel plate and rubber is not regarded as a critical factor for the cause of rupture and failure of the bearing.

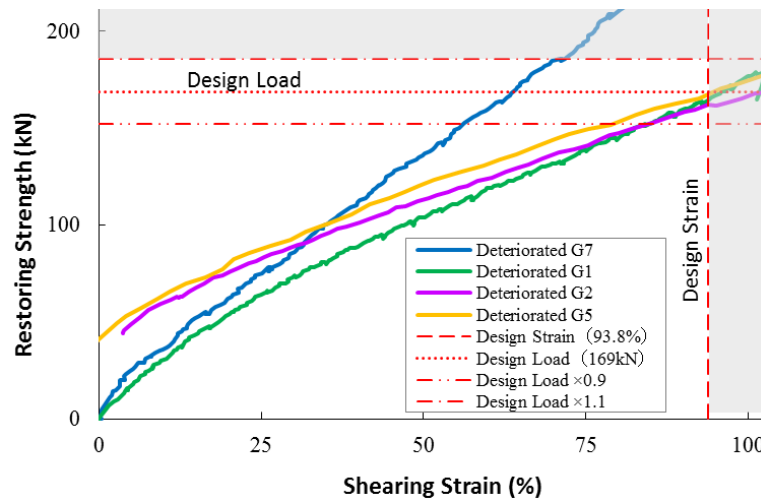
Figure 4.1 Design values and result of UD tests

Figure 4.1 shows the result of the UD tests in comparison with the design values. The strength of all deteriorated bearings exceeded the design load of 169kN, and the restoring forces at the design strain (93.8%) are found to be almost equivalent to the design load with a factor between 0.9 and 1.1, with the exception of G7. Therefore, the seismic residual performance of the deteriorated bearings is almost satisfactory with respect to the requirement for the Level 1 Earthquake. However, requirements for the Level 2 Earthquake (MCE) in the current seismic design specifications are yet to be investigated.
